REPORT ON THE LONG TERM RESULTS OF BATTERY CAPACITY RECOVERY PROCESSES FOR VRLA CELLS

Peter J. DeMar
Founder
Battery Research and Testing, Inc.

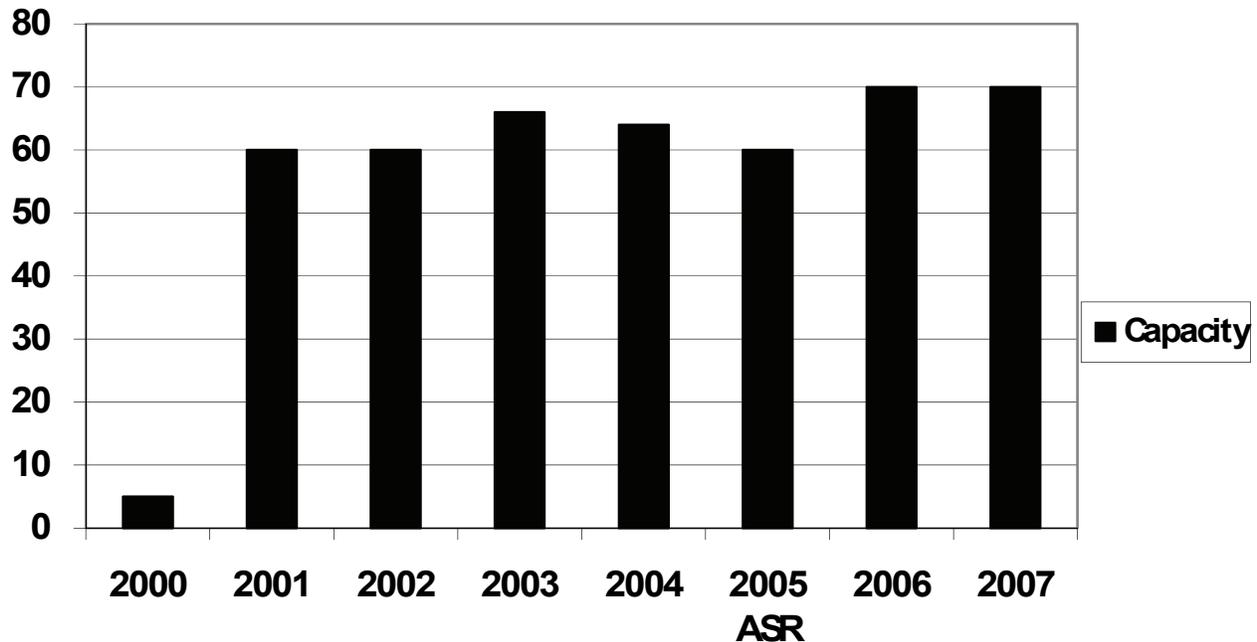
100A19

In October 2000, the first load test was run at the published three hour rate and the battery lasted nine minutes, which equates to 5% of its rating. This was followed by water and catalyst additions, which demonstrated an immediate improvement in the ohmic values. The following load test showed a capacity of 60% (108 minutes). This capacity, although not at 80% (as the IEEE 1188 recommends for time of replacement), was enough to support the site load for over 8 hours, which is what was needed for this customer. As you can see, the following annual load tests show the capacity remained pretty much the same, with no degradation for the next five years. Following the fifth year load test, the customer allowed Andersons Electronics (the company in Canada we have trained in how to perform our process) to add more water to each cell. In the initial stages of this project, the customer required there be only one initial water addition and no fine tuning as time went on. Throughout the development of this process, we have learned each new answer led to yet another question, and we learned the water volumes we thought correct during the initial phase of this research were, in fact, a moving target and difficult to precisely determine.

After this second watering of the cells, the following load test showed an increase in capacity from 60% to 70%, with no other actions taken. In 2006, there was one single drop of electrolyte from around one of the post seals. For this large telecom customer, this is a cause for replacement, even though the battery still had adequate capability to support the loads for over 8 hours (actually 9.8 hours), and, in fact, during the regional blackout of 2003, it supported the site for over 5 hours until a generator was brought to the site. Andersons Electronics took possession of this battery upon its removal from the site and moved it to their shop facility in London, Ontario and placed it on float at 54.0 volts, and continued the test program.

In 2007, it was again load tested and again made 70%, which seems to further contradict the generally accepted belief that, when a battery is less than 80%, it will accelerate in capacity loss, as these cells had been well under 80% for seven years and have stayed right where they were initially recovered to without any further decline. End of life or loss of capacity definitely was not caused by grid corrosion with this battery.

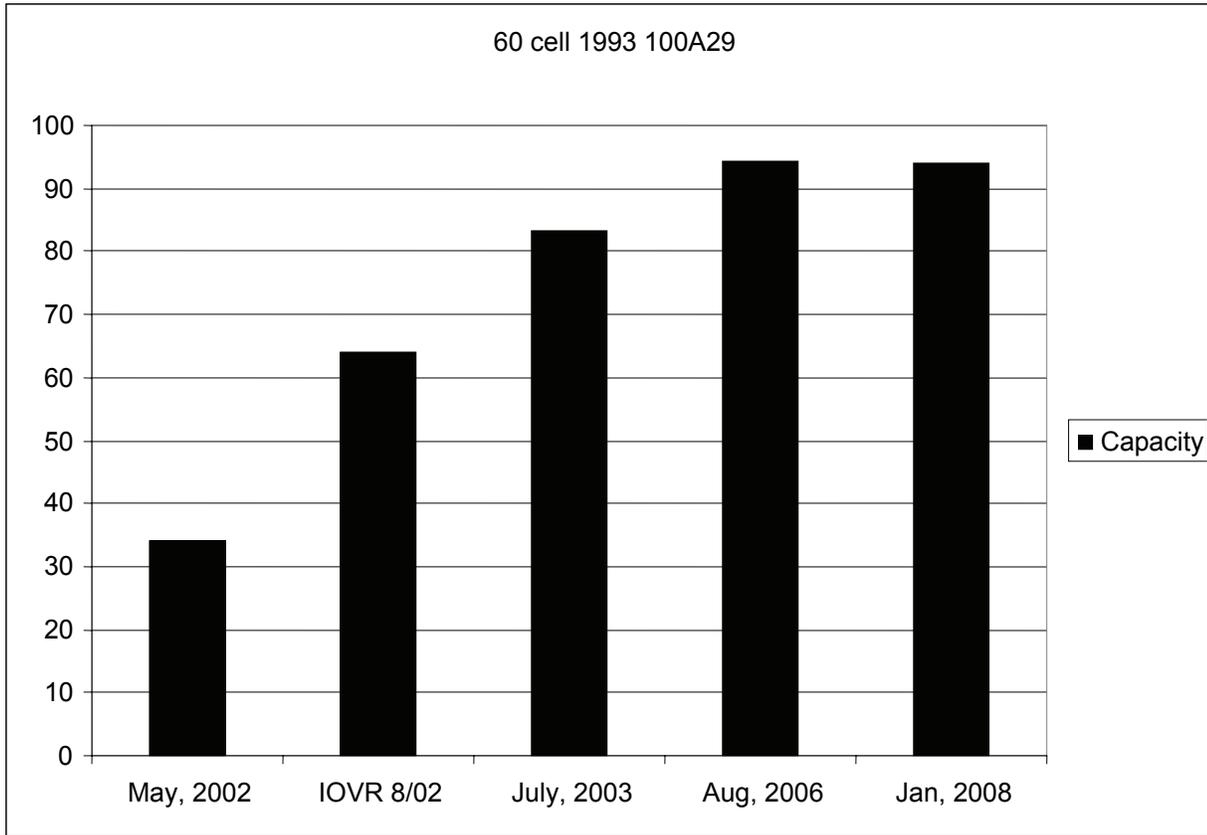
The following 60 cell 1993 100A29 battery was originally part of a 120 cell 100A87 string. It was replaced under warranty with three 120 cell 100A29 strings. We took possession of this battery in May of 2002 and, after configuring it into a number of 60 cell 100A29 strings, performed the initial load test, which produced 34.3% of its rated capacity. Following the performance of our initially developed recovery process, the battery was again load tested and produced 64.1% of its rated capacity. This battery was used in a variety of ways, such as training for performing our process, and in training in the running of load tests, with and without monitoring equipment functioning properly. There is no accurate number to how many load tests there were performed on this battery, nor at the actual rates run, as the training was to familiarize the trainees with a variety of issues involved in load testing, both at short rates (15 minute) and longer ones (up to 8 hours).

In July 2003, in order to prove this battery would support the steady state site loads at a particular nuclear plant during a planned outage, we ran another load test, but with more precision and monitoring and observers than had been during the training load tests. The battery satisfied the requirements of the customer and made 84% of its rating. This discharge test was followed by a high rate recharge. This high rate recharge was in order to restore the battery to a fully charged state as quickly as possible.

In August 2006, prior to another rental contract at a power plant, we ran yet another closely watched capacity test and the battery now made 94.2%.

In January 2008 we again ran a closely observed load test specifically for this paper and the battery made 93.9%.

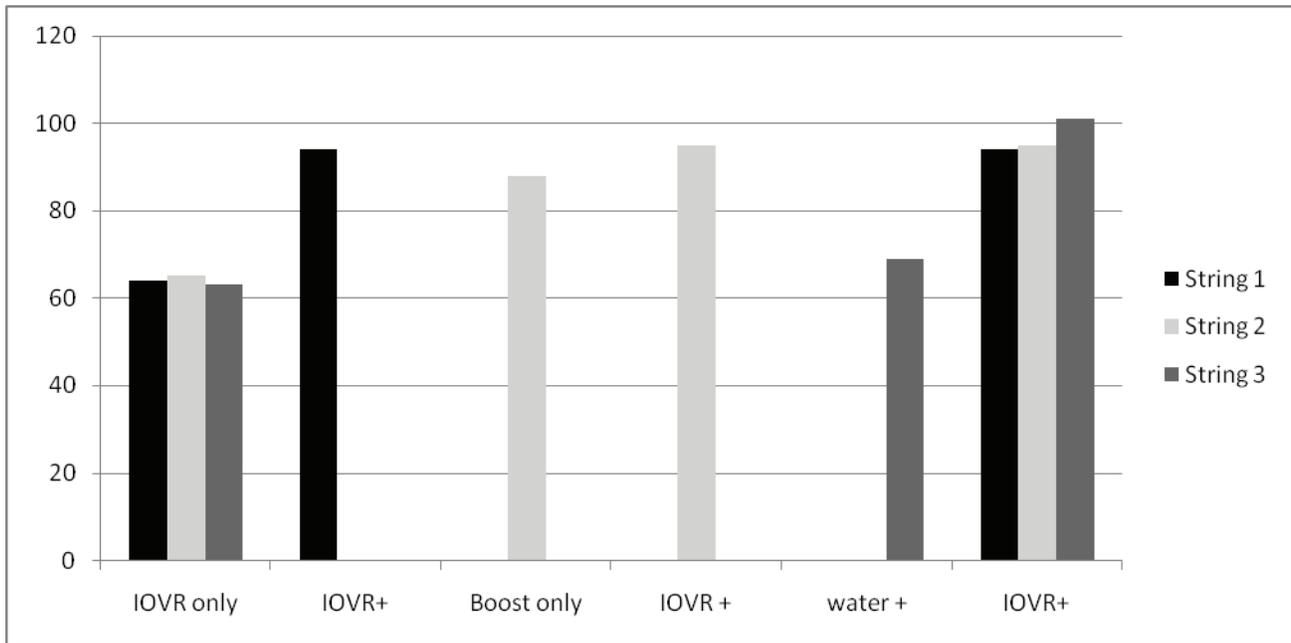
And, last but not least, are the reports on a 48 volt 100A99 battery, 1998 birth date that was re-assembled into three 24 cell 100A33 strings. We made three strings out of this one battery, so we could observe the results of each of the separate steps that go into the IOVR+ process. You will see that, following the initial IOVR process, the tested capacities were between 64 and 66 percent for each string.

We then added more water only to string 3, performed a boost charge only on string 2, and performed the complete IOVR+ process on String 1. String 1 recovered to 94% of its rating, String 2 to 88%, and string 3 improved from 66% to 69%. We then performed the additional steps of the IOVR+ process on string 2, and the subsequent load test resulted in 95% of its rating. We then went back to String 3, performed the IOVR+ process and the following capacity test resulted at 100.6% of its rating. We do think that possibly the extra amount of recovery in string 3 is due to the multiple discharge cycles, but that is a question for future research.
