Oh, Shoot: Battery knowledge gaps that plague the user community now that the old guys have retired

Dan McMenamin

Dan McMenamin and Associates, Inc.

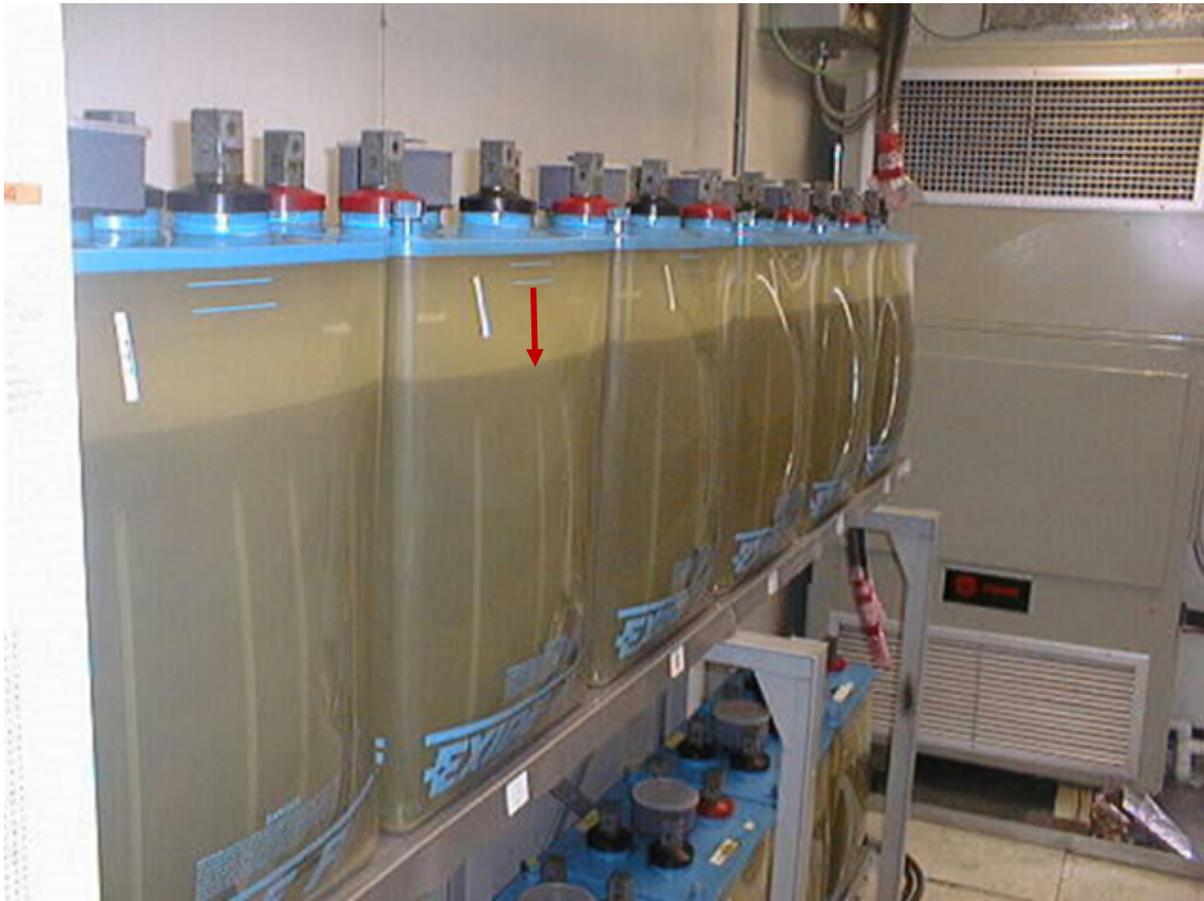
Figure 5. Lead calcium battery cells with containers that bulged due to an overheat condition in the wake of an HVAC system failure. Note the drastic electrolyte level drop (Arrows) that resulted from container bulging.

Figure 5 is a photograph showing damage to a vented string of 1,680 ampere hour cells caused by failure of the HVAC system in a telecommunications installation. Over a span of approximately 60 hours, the room temperature climbed to approximately 130 Degrees (F) (54.4⁰ C). Note the bulging evident on the sides of the battery containers.

The container material is PVC which softens at approximately 160 degrees (F) (71⁰ C). At this point, the battery internal resistance was functioning to some degree as an electric heater, fed by dc power from the plant rectifiers. Under such conditions, copious amounts of hydrogen are produced. Note also, that as the container sides bulged, the electrolyte level dropped beneath the filler-funnel tube of the explosion-resistant vents (sometimes called spark or flame arresting vents) atop each cell. These abnormal conditions placed the cell head-space (if not the facility itself) in a very serious threat of rapid combustion (the E-word) once the hydrogen concentration in any given volume of air would significantly exceed 4%. The cells if not the facility – as this section is named – was one spark away from a boom.

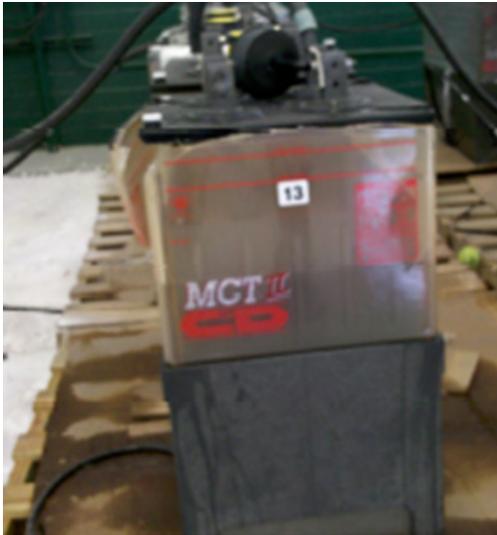
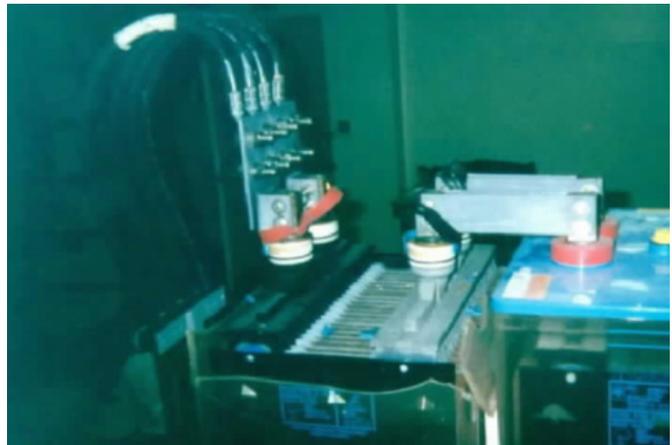
Figure 6. Battery cells destroyed by ESD mishandling. Personnel injuries were minor but potentially serious.

Across virtually all industries, cell destruction often is a mishandling event where ElectroStatic Discharge (ESD) of accumulated triboelectric energy leads to a spark that enters cell head space by various means and is an **ignition** source of to hydrogen/air concentrations that are elevated during relatively high rate charging. Two examples are shown in Figure 6. Most often, the ESD source is the clothing of someone who touches the cell, thus triggering a cell explosion. Such events spawn the potential for injury or worse and can easily be avoided by awareness and proper handling techniques.

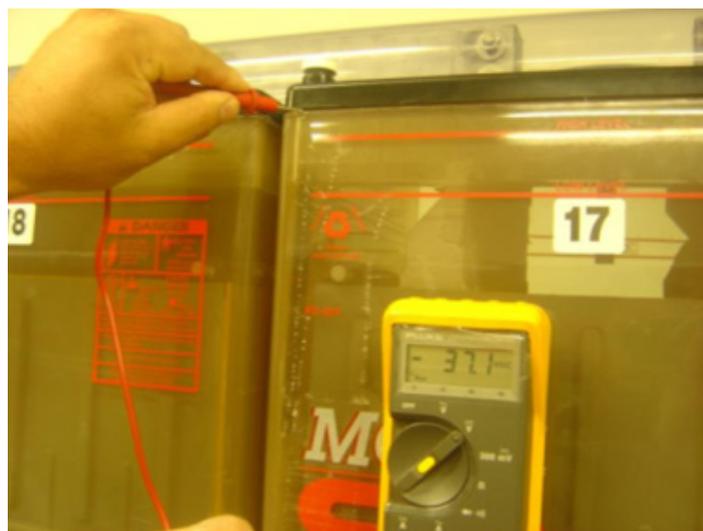
Figure 7. A leaking container-to-cover seal could result in a battery fire.

Intentionally grounded Battery systems, sometimes experience fires due to electrolyte streaking down the side of a battery container, usually from leaking container-to-cover seals or container cracks. Electrolyte is a conductive material when in a wet state or a residual one. If electrolyte finds an electrical path to a Grounded conductor such as a battery stand, a fire can result. Figure 7 shows a battery cell with a container to cover leak in an intentionally positive ground battery string. The streaks of electrolyte residue seen in the figure were the first reason to suspect a defective cover to container seal. The condition is then verified by connecting a voltmeter between a Grounded conductor and then tracing the other probe along the container to cover junction. If the seal is good, no voltage will be observed on the meter. In this case, 37.1 volts are seen indicating a defective seal. The voltage observed is a function of that cell's position in the string times the float per-cell voltage. In this case, cell 17 times 2.18 volts per cell equals 37 volts. Generally, the further (in cell number) above the Grounded cell, the higher the voltage available to a fault condition and therefore the greater likelihood of a battery fire.
