# IMPROVING LIFE EXPECTANCY OF VRLA BATTERIES INSTALLED IN OUTDOOR CABINETS

**John A Zulaski**  
**Engineering Fellow**  
**S&C Electric Company**  
**Chicago, Illinois 60626**

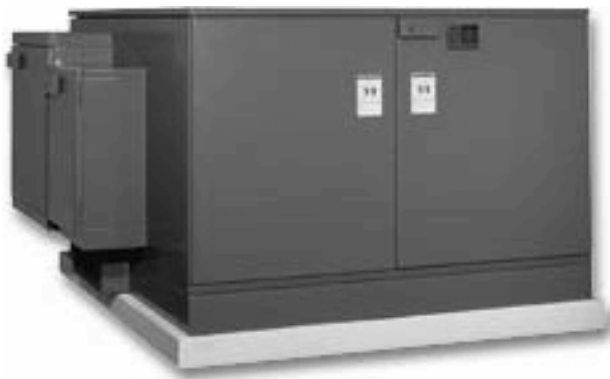
**Figure 1. S&C Remote-Supervisory Pad-Mounted Gear.**

S&C Electric Company is a manufacturer of switching and protection equipment for the electric power industry. S&C's Remote Supervisory Pad-Mounted Gear, illustrated in Figure 1, is utilized for automated switching of medium-voltage underground distribution feeders. This gear is typically installed outdoors. The low-voltage enclosure that houses a switch operator and the controls is mounted on the left-hand side of the high-voltage enclosure, as shown. (It is the smaller of the two enclosures.)

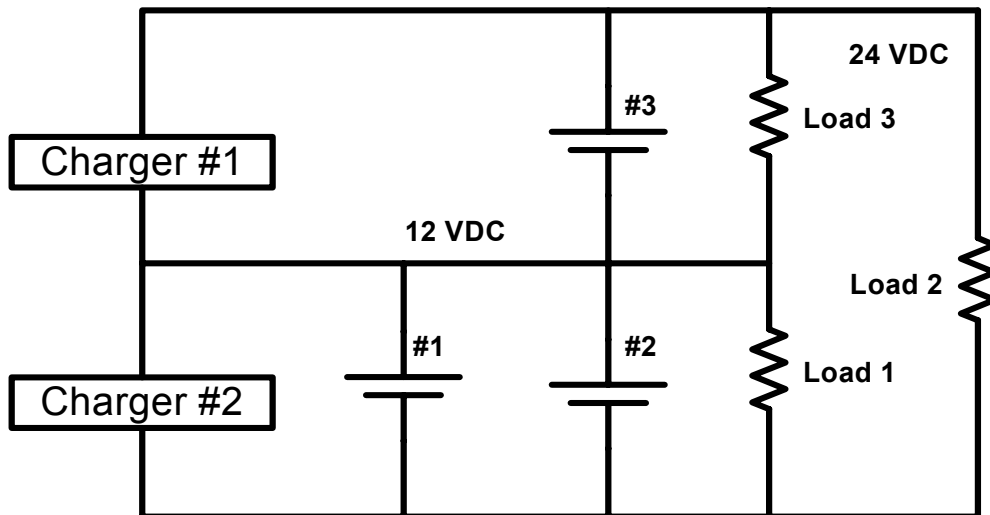
Figure 3 Battery System

The circuit diagram in Figure 3 illustrates a battery system consisting of 3 batteries connected in series and parallel. Loads 1 and 3 are each 12 volts dc and Load 2 is 24 volts dc. Two temperature-compensated battery chargers are utilized.

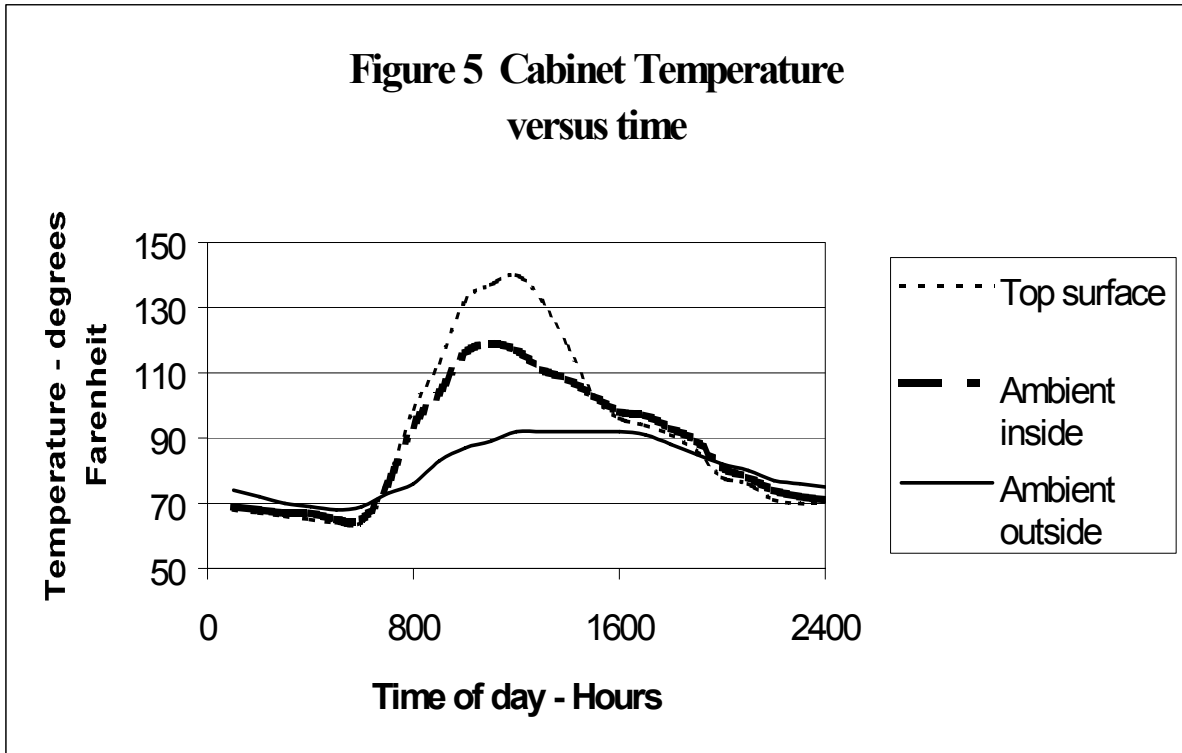
S&C contracted for a study of internal temperatures of low-voltage enclosures exposed to solar heating. Tests were conducted at a laboratory in Phoenix Arizona. Figure 5 illustrates a typical 24-hour pattern of temperature variation in the enclosure. On the average, the internal cabinet temperature seems reasonable. Locating the batteries at the bottom of the cabinet is consistent with the lowest temperature readings within the enclosure. Note, however, the temperature of the

cabinet surface. At midday, the top surface temperature can be 20 to 25 degrees Fahrenheit hotter than the inside ambient temperature. Since the batteries are mounted against the outside cabinet wall, shortened life could result. Insulating the batteries to reduce peak temperature excursions would seem to be a cost-effective way to solve the problem.

If indeed dryout of the end cells is caused by radiation heating, a solution would be to eliminate the source of the radiated heat with some form of insulation on the South- or West-facing wall. An alternative would be a factory modification that insulates the entire battery from radiation heating.

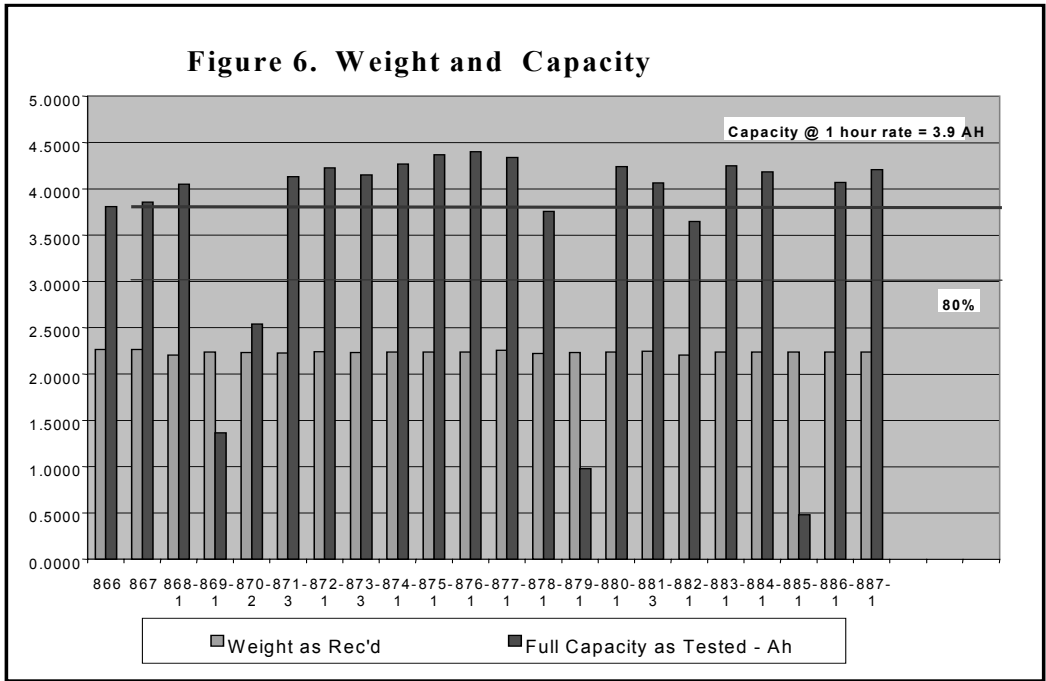
**Figure 6. Weight and Capacity**

The batteries are rated 3.9 ampere-hours at the 1-hour rate and are considered to be defective at 80% of capacity, or 3.12 ampere-hours. In this sampling, 4 batteries are judged to be defective and are identified in bold. The weight and open-circuit voltage of the batteries are plotted in Figures 6 and 7, respectively, along with capacity.

Examination of Figures 6 and 7 shows that neither battery weight nor open-circuit voltage give any indication of battery capacity. Why this is true became apparent after the batteries were disassembled. More on that later.

Another observation of interest from Figure 6 is that a high percentage of the batteries are at or above full capacity. So some batteries are very bad . . . but most batteries are very good and have many months of remaining life.

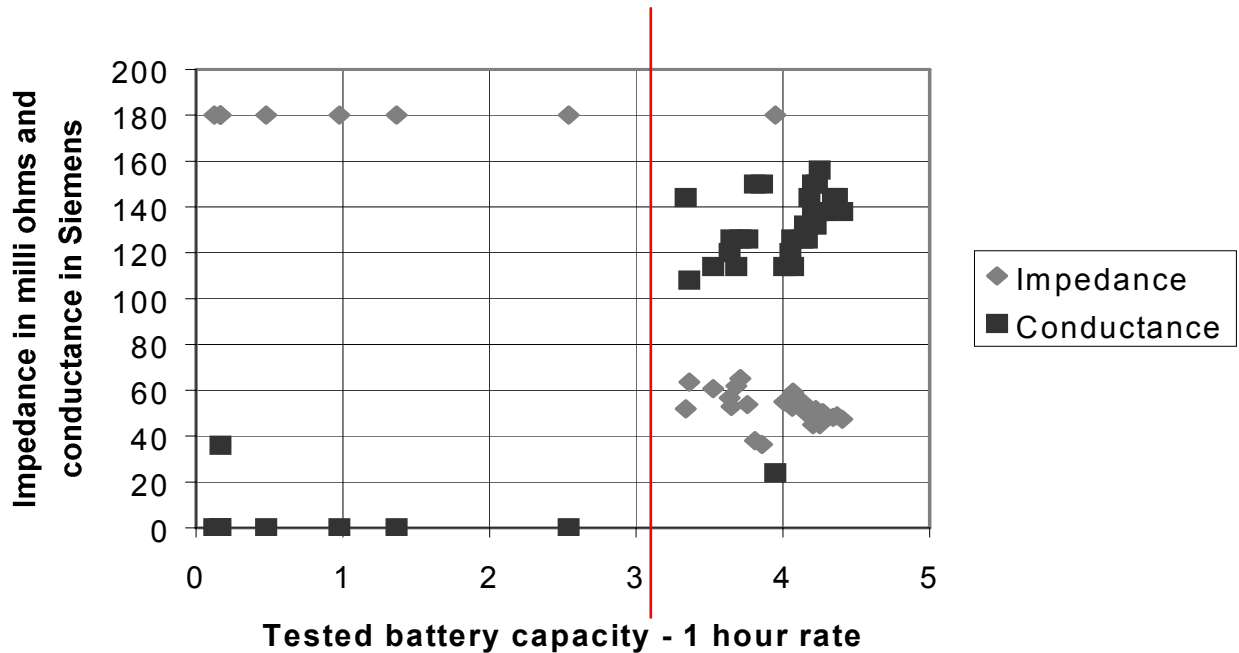
**Figure 8. Impedance and Conductance variation versus tested battery capacity**

Measurements of impedance and conductance were made and compared to tested capacity. These measurements are shown in the scatter plot in Figure 8 and indicate a very strong correlation with tested capacity. This finding is significant because a method of quickly and easily measuring relative battery capacity would be very useful to customers, and would help them determine the remaining life of units in the field. Potentially, batteries could be replaced as they near end of life, instead the present method of mass changeout at fixed intervals.

Note the single low reading of conductance and high reading of impedance at nearly 4 ampere-hours. This was the result of a poor intercell connection and points out the ability to find problems other than low capacity. The zero Siemens readings from the conductance tester and the 180 ohm readings for the impedance tester represent out of range indications from the meters.

- Modification of the way the batteries are installed in the cabinet, to preclude single cell heating from cabinet wall-radiated heat, including thermal isolation between the battery and the walls of the cabinet.
- More precise control of battery charger float voltage.
- Improvement in the operating environment for the batteries, through better air circulation around the batteries.
- Development of a simple field test procedure to be implemented by customers, to identify weak batteries that may be replaced prior to failure (rather than wholesale replacement of batteries on a scheduled basis).

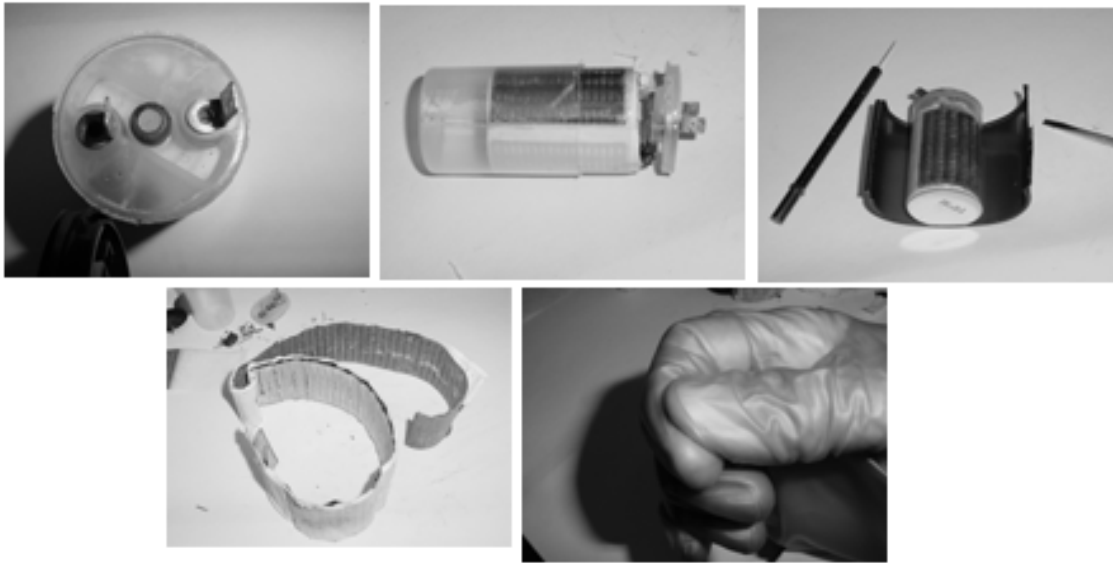
**Figure 9. Typical details of a defective cell**

Note that in every defective battery, one of the end cells had a very low open-circuit voltage, while the remaining cells were essentially the same. Further disassembly of the end cells was the next step, and is illustrated in Figure 9.

Notes: Cells in the first four rows were discharged for disassembly

Cells in bottom four rows are fully charged

In all the failed cells, the separator appeared to be very dry and electrolyte could not be extracted by compressing the glass mat separator (the photo showing the gloved hand). It was also noted that the paste material on the positive and negative plates was very brittle and cracked easily, indicating a dryout condition. No signs of active corrosion were noted in any of the defective cells. In addition, although the plates appeared dry, there were no signs of sulfation. No sign of dendrites were noted in any of the defective cells.

Cell dryout was seen to be the primary cause of failure of the field-returned batteries. Of even greater importance is the cause of cell dryout. It was noted that all units operate at elevated temperatures, typically in the 32 to 35 degrees C range. Using the standard rule of thumb of one-half expected life for each 10 degrees C above 25 C, one would expect that the batteries should have an operational life of at least 4 years. (This is based on a life of 8 years at 25 degrees C for float applications, as specified by the manufacturer.) With that in mind, one might assume that dryout of an individual cell is caused by something other than the operational temperature environment of the entire battery. Considering the orientation of the batteries within the enclosure, cells located next to the South- or West-facing wall of the enclosure may be exposed to high radiation heating directly from the wall of the enclosure. The remaining cells not in direct contact with the outside wall would be somewhat insulated from radiation heating. If so, the end cell(s) would operate at much higher temperatures than the remaining cells, leading to premature failure as was found in the test group.

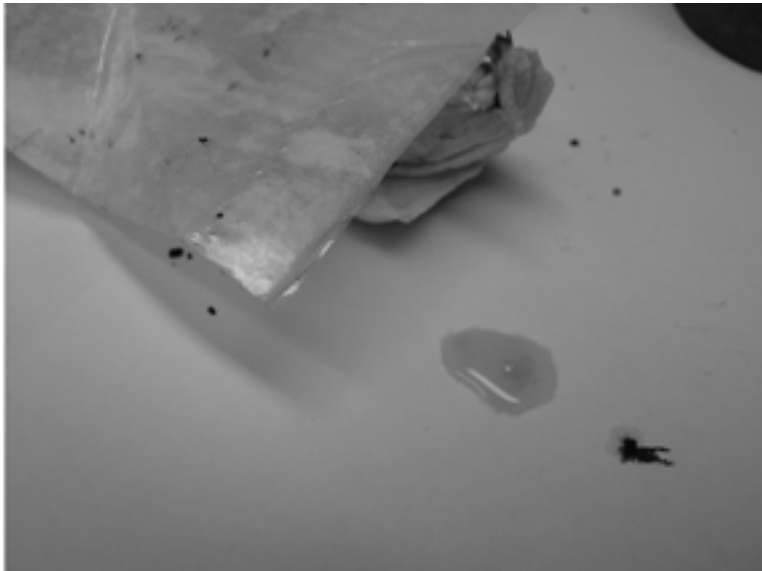
**Figure 10. Typical details of a new cell**

In contrast, disassembly of a new cell, shown in Figure 10, indicated that the glass mat was saturated with electrolyte. The electrolyte was easily squeezed out of the mat, as shown by the puddle in the lower right hand corner of the photo. The glass mat was easily separated from both the positive and negative plates. The plates themselves were very pliable and did not show the cracking noted in the failed cells. It was also very easy to slip the inner cylinder out of the outer plastic shell. In the failed units, the plastic shell had to be cut and peeled off the cylinder in order to remove the cell components.

The most remarkable observation made during the disassembly of this cell was the apparent saturation of the glass mat with electrolyte and the pliability of the plates observed during the unrolling of the cell “jelly roll.” None of the failed cells exhibited

these qualities. There were also no signs of corrosion in any area of the cell, including the post areas. It was also noted that the glue used to hold the cells together was very pliable and quite soft. In the field-returned units, after removal of the shrink-wrap, it was noted that many of the glue blocks were detached from the individual cells, and had become stiff and hard. This may also be evidence of operation at elevated temperatures.
